## **Vaughn Palmer: A ‘dangerous game’ at Mount Polley preceded disaster, according to senior engineer**

**‘Remember, if they lose the dam, the mine can’t operate anyways’**

By Vaughn Palmer, Vancouver Sun columnist February 2, 2015 9:41 PM

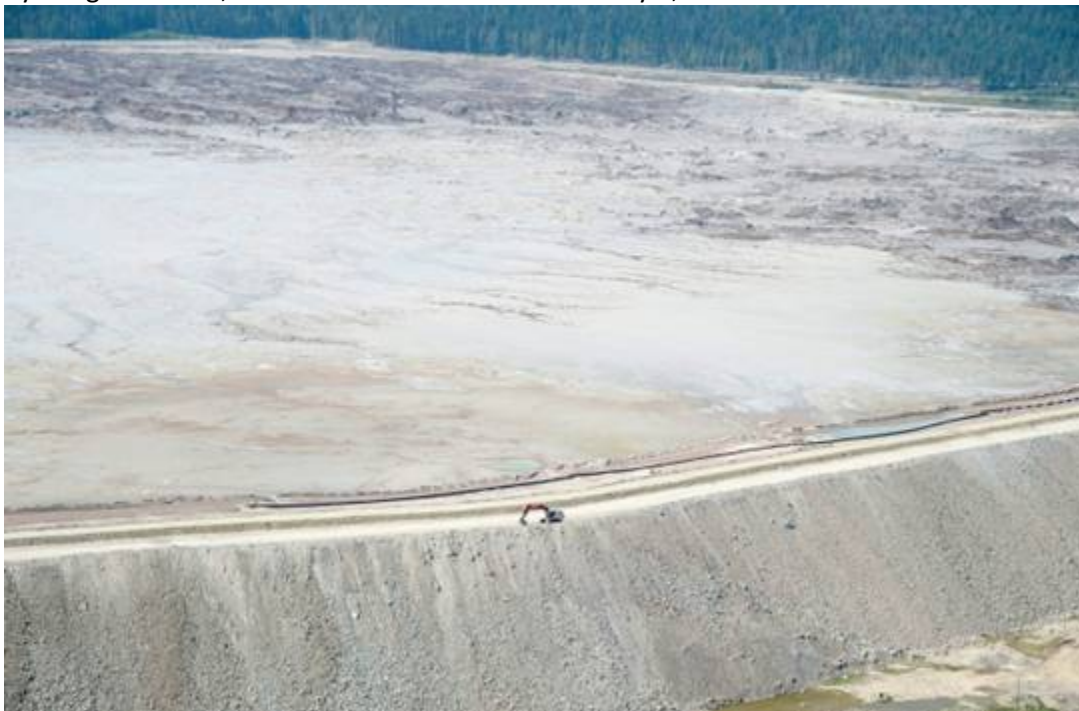
*An aerial view of a barely visible excavator atop the Mount Polley tailings dam gives an idea of the size of the storage pond. The dam gave way near the town of Likely, B.C., on Aug. 5, 2014, polluting nearby waterways and lakes. Photograph by: JONATHAN HAYWARD , THE CANADIAN PRESS*
